**NATIONAL REGISTER OF HISTORIC PLACES
CONTINUATION SHEET**

Yosemite Valley
Property Name

NATIONAL REGISTER OF HISTORIC PLACES NOMINATION FORM

PART III: BUILDING AND STRUCTURE INVENTORY
Supplemental Information for Section 7

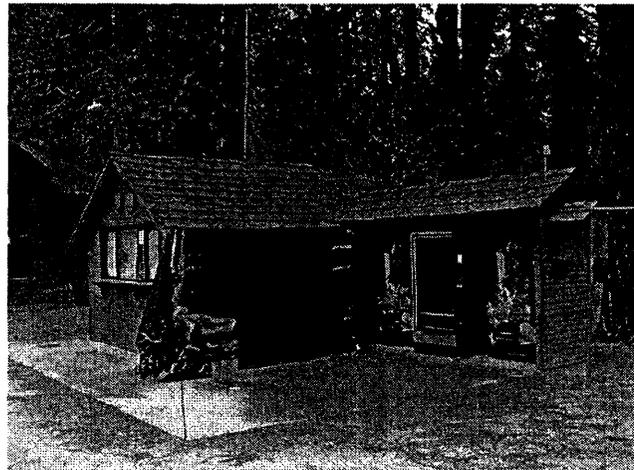
Built 1927. 1 story, wood frame. ~10x12' with long section to East to shelter vending machines. Gable roofs, rough split shake shingles. Clapboard siding. Small gable roof over side door. Concrete slab foundation.

Concessioner Stables Office, looking northeast.

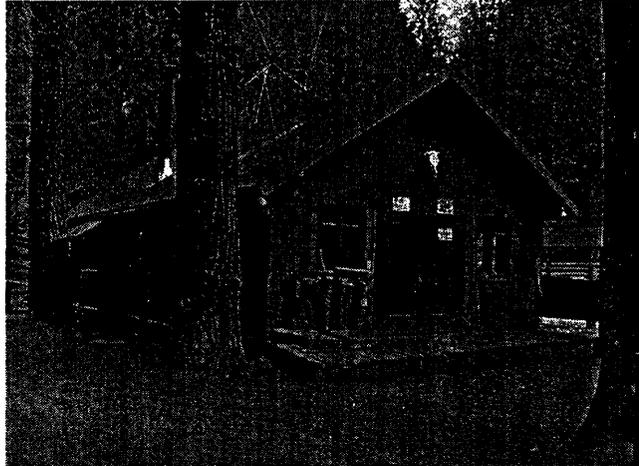
DESCRIPTION: Built 1927. 1 story, wood frame. ~12' x 24'. Gable roof, asphalt shingles (over original sugarpine shake). Sugarpine shake siding. Wood floor on piers. Large double doors at south end open onto wooden platform.

Concessioner Stables Harness Shop, looking northeast.

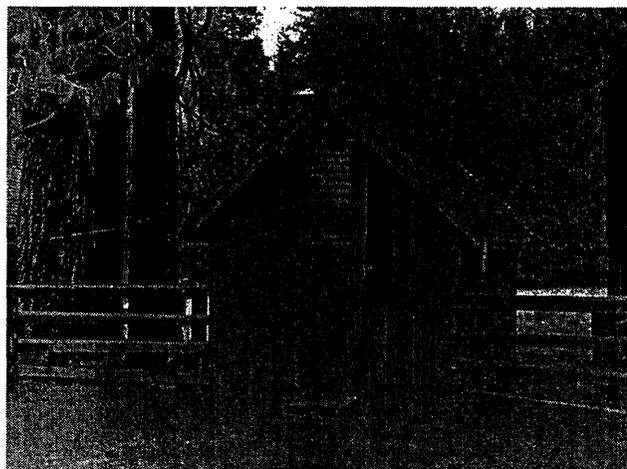
BUILDING NAME: Concessioner Stables Pony Tack Shed #1**STRUCTURE #/ LCS****ID #:** VSS007 / 056056**MAP #:** Maps A & A1 Detail, B11**DESCRIPTION:** Built 1926. 1 story, wood frame. ~8'x10'. Gable roof, cedar shingles. Board and batten siding. Doors front and rear, 2 windows rear (East side). These cabins are reported to have housed men who worked on the O'Shaughnessy Dam.

Concessioner Stables Pony Tack Shed #1, looking east.

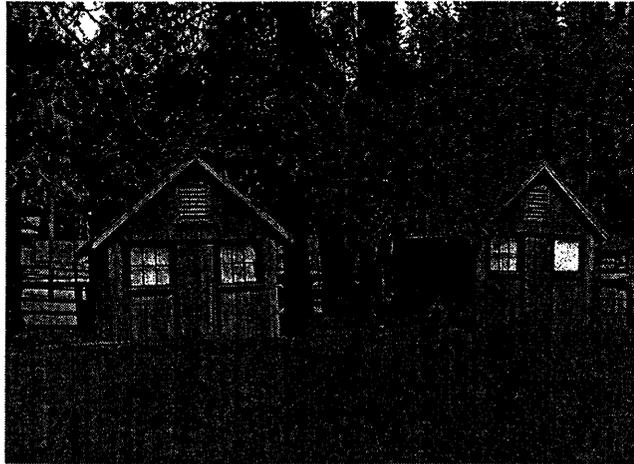
Built 1926. 1 story, wood frame. ~8'x10'. Gable roof, cedar shingles. Board and batten siding. Doors front and rear, 2 windows rear (East side). These cabins are reported to have housed men who worked on the O'Shaughnessy Dam. Same as Tack Shed 1.

Concessioner Stables Pony Tack Sheds #1 (left)
and #2 (right), looking west.

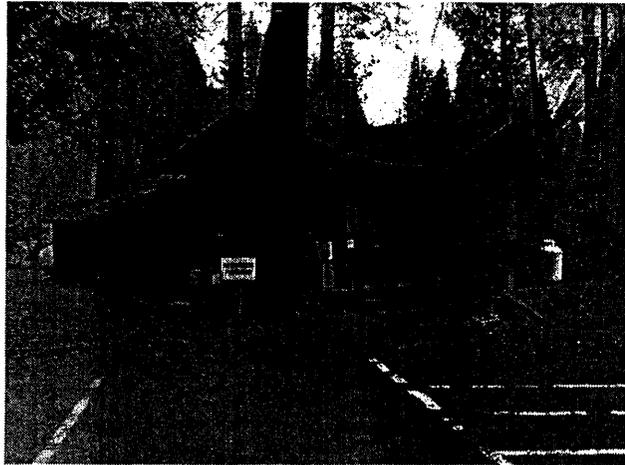
BUILDING NAME: Concessioner Stables Employee Residence
STRUCTURE #/ LCS
ID #: VSE006 / 056059
MAP #: Maps A & A1 Detail, B13
DESCRIPTION: Built 1927. 1 story wood frame. Highly offset floor plan. Multi-tiered gable roofs, asphalt shingles. Siding: board and batten (not original) and sugarpine shake. 2x6 rafters. Foundation covered by skirt board. Small front porch. Small storage shed at rear connected with tall fence. Picturesque, fenced-in back yard.

Concessioner Stables Residence, looking northeast.

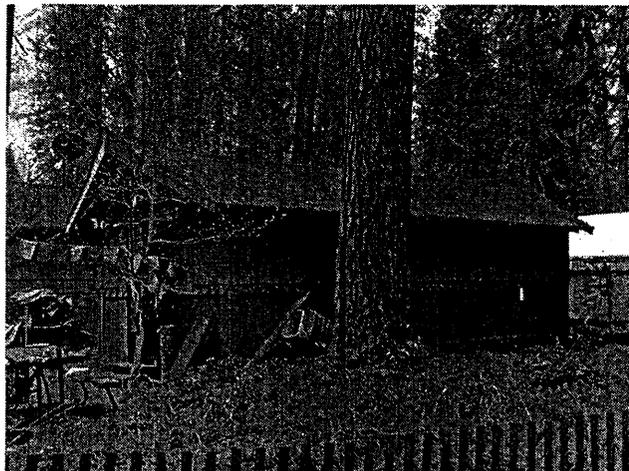
BUILDING NAME: Concessioner Stables Employee Cabin #6A
STRUCTURE #/ LCS
ID #: VSE012 / 056061
MAP #: Maps A & A1 Detail, B14
DESCRIPTION: Built 1927. 1 story, wood frame. ~12' x 20'. "Conestoga" gable roof, pointed outward at peaks, asphalt shingles. T&G wainscot to shark tooth mid-band. Sugarpine shake above. Wood floor on piers. gingerbread style. Clad, slider windows are replacements.

Concessioners Stable Cabin 6A, looking south.

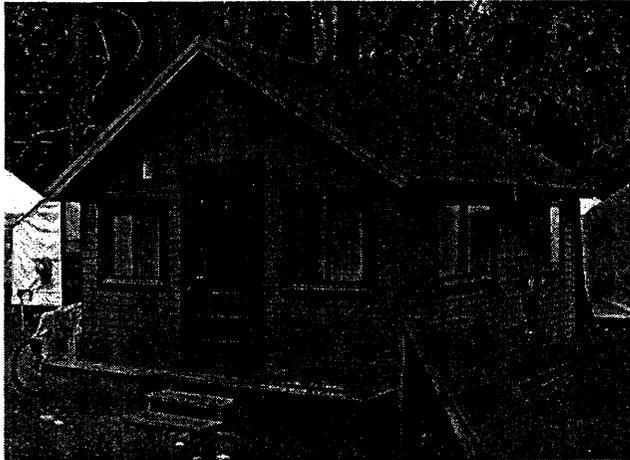
BUILDING NAME: Concessioner Stables Employee Cabin #7
STRUCTURE #/ LCS
ID #: VSE014 / 205047
MAP #: Maps A & A1 Detail, B15
DESCRIPTION: Built 1927. 1 story, wood frame. ~10' x 12'. Gable roof, asphalt shingles. Clapboard siding. Built on piers. Skirt boards. Clad, slider windows (replacement).

Concessioner Stables Cabin 7, looking southwest.

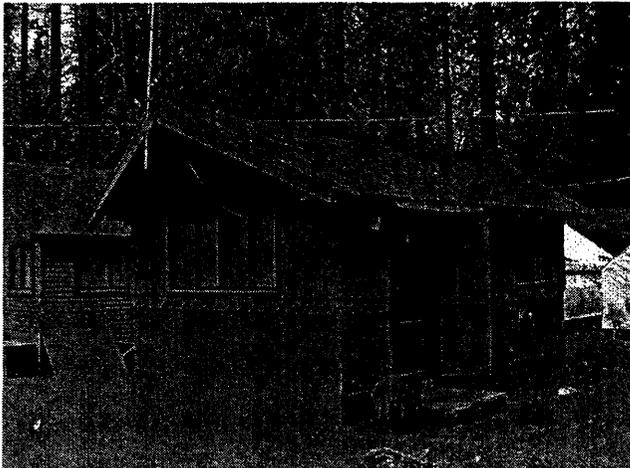
BUILDING NAME: Concessioner Stables Employee Cabin #8
STRUCTURE #/ LCS
ID #: VSE015 / 25059
MAP #: Maps A & A1 Detail, B16
DESCRIPTION: Built 1927. 1 story, wood frame. ~10' x 14'. "Conestoga" gable roof, pointed outward at peaks, asphalt shingles. T&G wainscot to shark tooth mid-band. Sugarpine shake above. Wood floor on piers. Gingerbread style. Clad, slider windows (replacement).

Concessioners Stable Cabin 8, looking southwest.

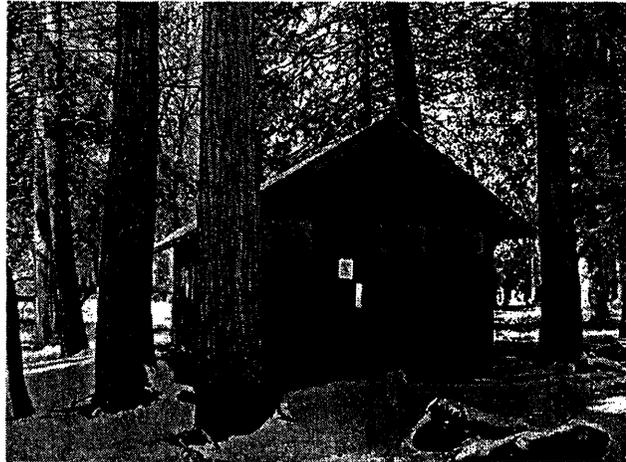
Camp 15 Comfort Station #421.

DESCRIPTION: Built 1923-1924. 1 story, exposed wood frame. ~10' x 20'. Gable roof; cedar shingles. Open eaves. Vertical wide-board siding + 2x timber detailing. Plate windows ends, screens on sides at ~ 7' high. Concrete foundation and slab. Bead board interior walls. Panel with 1/2 round molding on ceiling. Camp 15 is no longer in use due to the '99 flood.

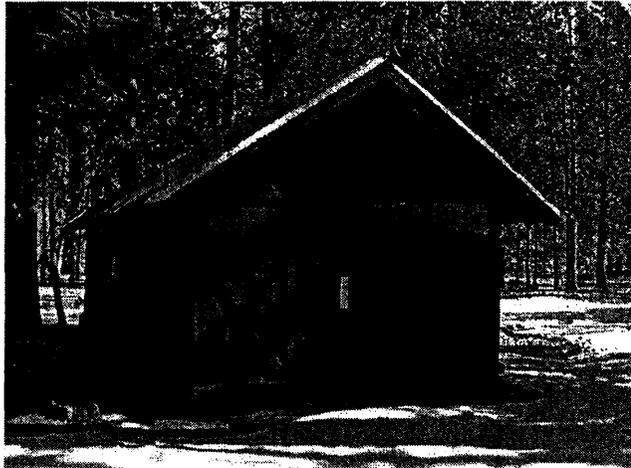
Camp 15 Comfort Station #422.

DESCRIPTION: Built 1923-1924. 1 story, exposed wood frame. ~10' x 20'. Gable roof; cedar shingles. Open eaves. Vertical wide-board siding + 2x timber detailing. Plate windows ends, screens on sides at ~ 7' high. Concrete foundation and slab. Bead board interior walls. Panel with ½ round molding on ceiling. Camp 15 is no longer in use due to the '99 flood.

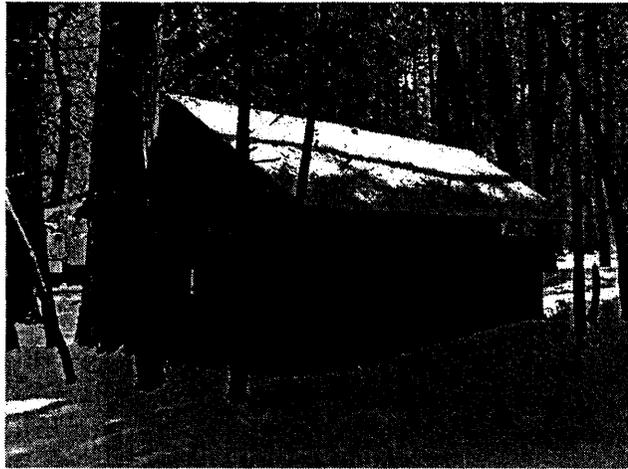
Camp 15 Comfort Station #423.

DESCRIPTION: Built 1923-1924. 1 story, exposed wood frame. ~10' x 20'. Gable roof; cedar shingles. Open eaves. Vertical wide-board siding + 2x timber detailing. Plate windows ends, screens on sides at ~ 7' high. Concrete foundation and slab. Bead board interior walls. Panel with 1/2 round molding on ceiling. Camp 15 is no longer in use due to the '99 flood.

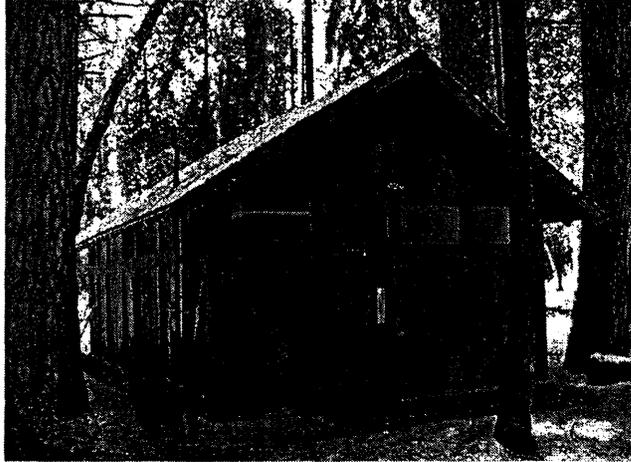
Camp 15 Comfort Station #424.

DESCRIPTION: Built 1923-1924. 1 story, exposed wood frame. ~10' x 20'. Gable roof; cedar shingles. Open eaves. Vertical wide-board siding + 2x timber detailing. Plate windows ends, screens on sides at ~ 7' high. Concrete foundation and slab. Bead board interior walls. Panel with ½ round molding on ceiling. Camp 15 is no longer in use due to the '99 flood.

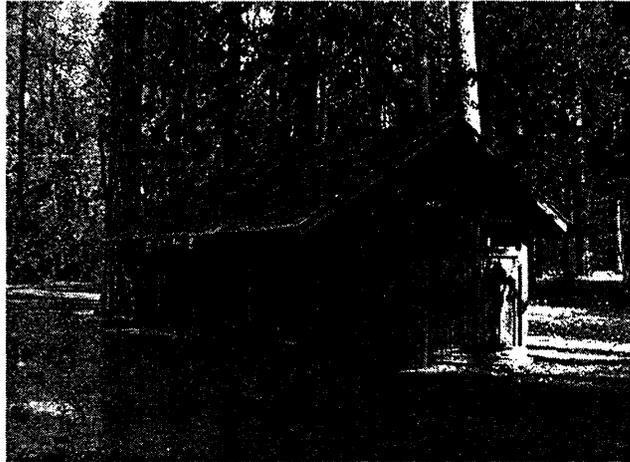
Camp 7 Comfort Station #428.

DESCRIPTION: Built 1922. 1 story, exposed wood frame. ~10' x 20'. Gable roof; cedar shingles. Open eaves. Vertical wide-board siding + 2x timber detailing. Plate windows ends, screens on sides at ~ 7' high. Concrete foundation and slab. Bead board interior walls. Panel with 1/2 round molding on ceiling. Camp 7 is no longer in use due to the '99 flood.

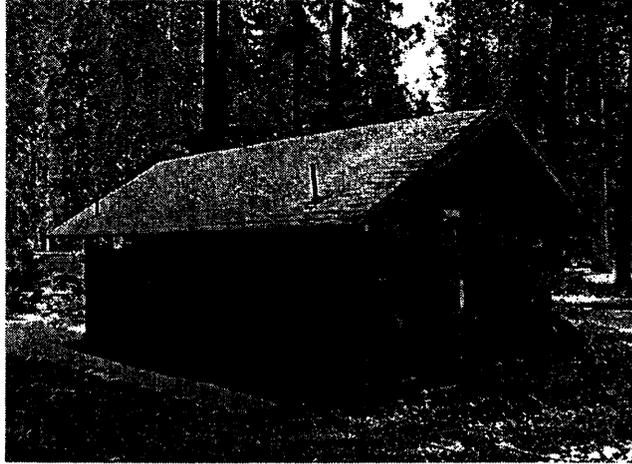
Camp 7 Comfort Station #429.

DESCRIPTION: Built 1922. 1 story, exposed wood frame. ~10' x 20'. Gable roof; cedar shingles. Open eaves. Vertical wide-board siding + 2x timber detailing. Plate windows ends, screens on sides at ~ 7' high. Concrete foundation and slab. Bead board interior walls. Panel with ½ round molding on ceiling. Camp 7 is no longer in use due to the '99 flood.

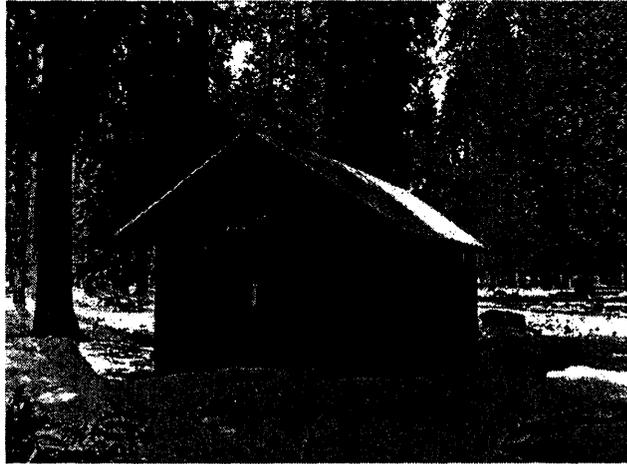
Camp 7 Comfort Station #430.

DESCRIPTION: Built 1922. 1 story, exposed wood frame. ~10' x 20'. Gable roof; cedar shingles. Open eaves. Vertical wide-board siding + 2x timber detailing. Plate windows ends, screens on sides at ~ 7' high. Concrete foundation and slab. Bead board interior walls. Panel with ½ round molding on ceiling. Camp 7 is no longer in use due to the '99 flood.

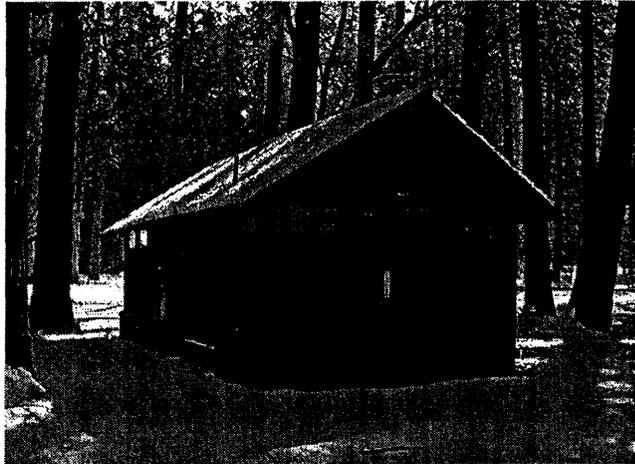
Camp 7 Comfort Station #431.

DESCRIPTION: Built 1922. 1 story, exposed wood frame. ~10' x 20'. Gable roof; cedar shingles. Open eaves. Vertical wide-board siding + 2x timber detailing. Plate windows ends, screens on sides at ~ 7' high. Concrete foundation and slab. Bead board interior walls. Panel with ½ round molding on ceiling. Camp 7 is no longer in use due to the '99 flood.

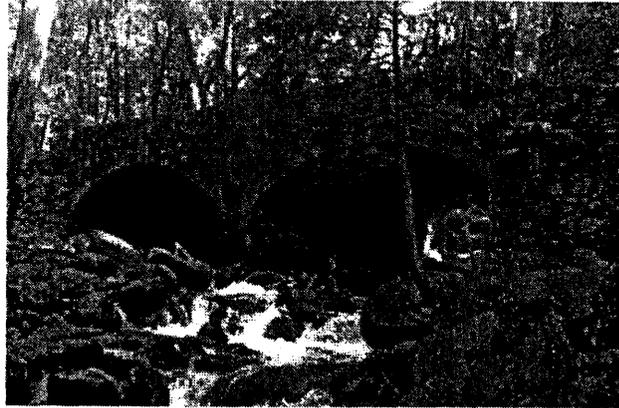
STRUCTURE NAME: Bridalveil Fall Bridge No.2
STRUCTURE #/ LCS
ID #: BR00103 / 056082
MAP #: Map A, S7
DESCRIPTION: Built 1913. Double arch span bridge on road passing by the foot of Bridalveil Falls. The NPS constructed the spandrel walls and roadway.

Bridalveil Fall Bridge No.2, facing south.

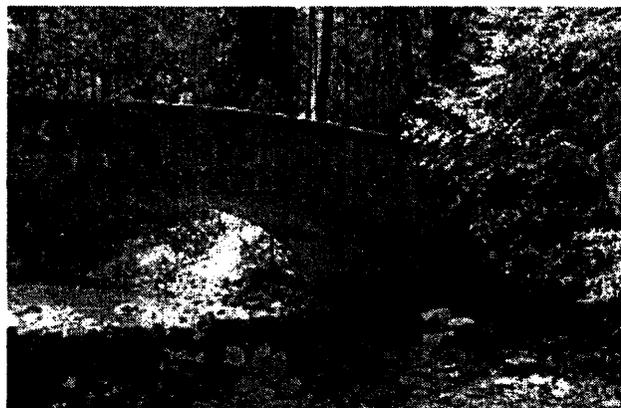
Built 1927. Single span arch bridge, 52' long, 24' wide. Reinforced concrete arch veneered with local granite. Spans 50'. Parapet walls with overhanging granite coping. Keystone at top of arch. 2 traffic lanes. Crosses Yosemite Creek on North Road.

Yosemite Creek Bridge.

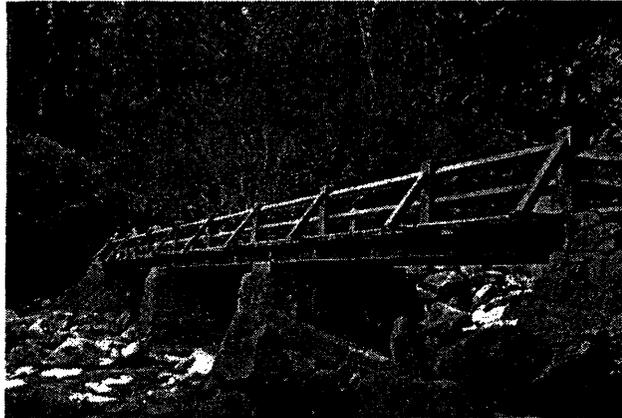
STRUCTURE NAME: Yosemite Creek Footbridge (directly below Yosemite Falls)
STRUCTURE #/ LCS
ID #: 059888 / BR00014
MAP #: Map A, S16
DESCRIPTION: Built c. 1939. Stone abutments, steel beams, wood decking, wood railings, stone ramps lead up to bridge are paved with concrete. ~6' wide.

Yosemite Creek Footbridge (directly below Yosemite Falls).

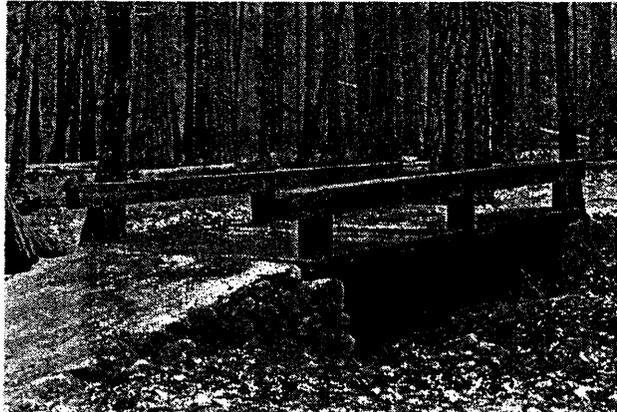
STRUCTURE NAME: Yosemite Falls Trail Footbridge No. 2.
STRUCTURE #/ LCS
ID #: None
MAP #: Map A, S18
DESCRIPTION: Stone abutments, steel beams, wood decking, wood railings, stone ramps lead up to bridge are paved with concrete. ~6' wide.

Yosemite Falls Trail Footbridge No. 2.

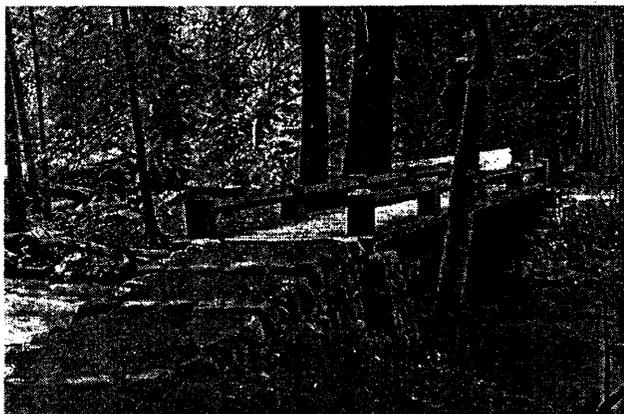
STRUCTURE NAME: Yosemite Falls Trail Footbridge No. 4.
STRUCTURE #/ LCS
ID #: None
MAP #: Map A, S20
DESCRIPTION: Stone abutments, steel beams, wood decking, wood railings, stone ramps lead up to bridge are paved with concrete. ~6' wide.

Yosemite Falls Trail Footbridge No. 4.

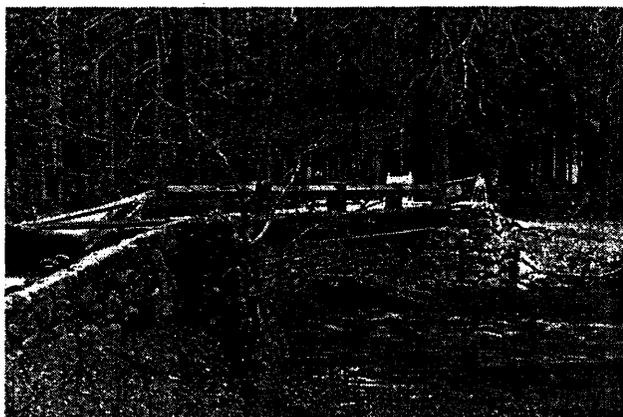
STRUCTURE NAME: Yosemite Falls Trail Footbridge No. 5
STRUCTURE #/ LCS
ID #: None
MAP #: Map A, S21
DESCRIPTION: Stone abutments, steel beams, wood decking, wood railings, stone ramps lead up to bridge are paved with concrete. ~6' wide.

Yosemite Falls Trail Footbridge No. 5.

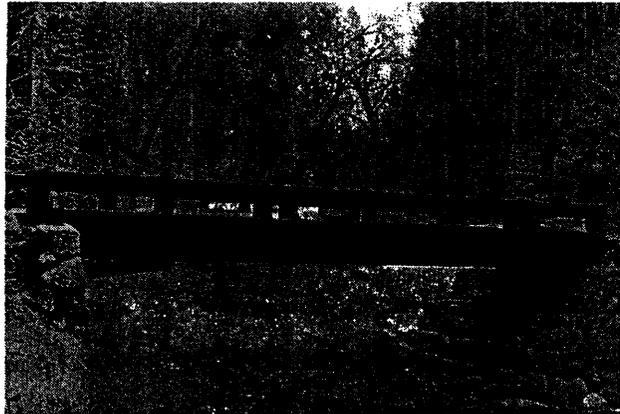
DESCRIPTION: Stone abutments, steel beams, wood decking, wood railings, stone ramps lead up to bridge are paved with concrete. ~6' wide.

Yosemite Falls Trail Footbridge No. 6 (closest to parking lot).

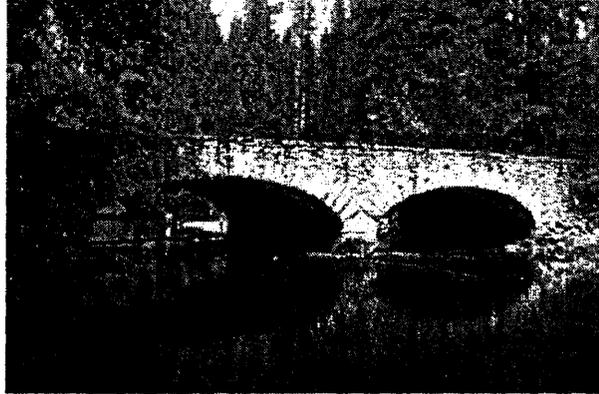
STRUCTURE NAME: Ahwahnee Bridge
STRUCTURE #/ LCS
ID #: BR00006 / 012960
MAP #: Map A, S26
DESCRIPTION: Built 1928. Triple arched span, 122' long, 39' wide. Reinforced concrete arches, veneered with local granite. 2 traffic lanes, 27' roadway & 1 sidewalk 5' wide. 1 bridal path, 7' wide.

Ahwahnee Bridge.

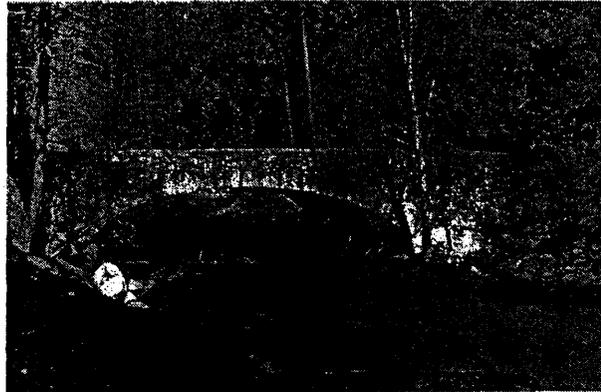
Built 1928. Single span arch, 58' long, 39' wide. Reinforced concrete arch veneered with native granite. 2 lane of traffic, roadway 27', one sidewalk 5', 1 bridal path 7'. Crowned in center w/ parapet walls. Crosses Tenaya Creek on Happy Isles/ Mirror Lake R

Tenaya Creek Bridge.

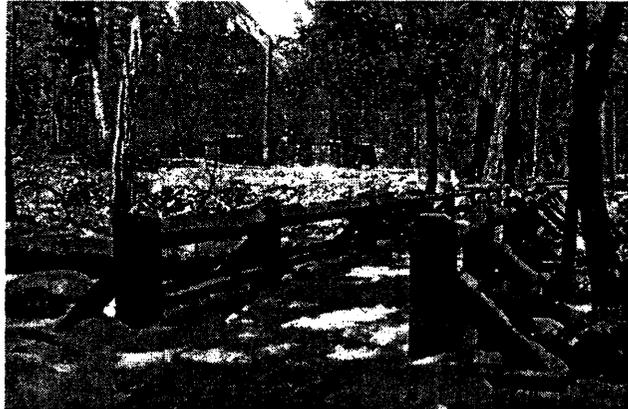
DESCRIPTION: Reconstructed 1997 utilizing historic abutments. Stone abutments and middle pier, steel stringers, pressure-treated lumber decking and railings. ~8' wide, 80' long.

Happy Isles Middle Bridge.

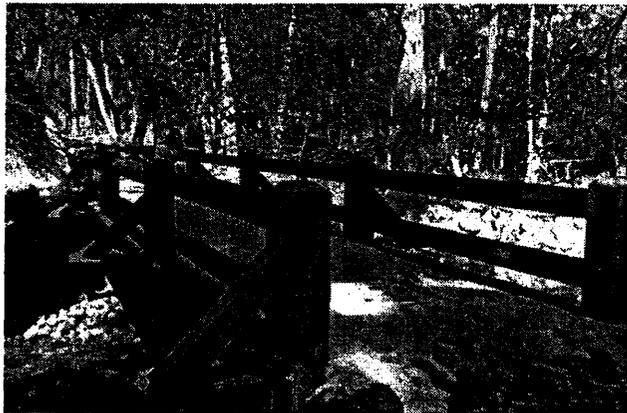
DESCRIPTION: Reconstructed 1997 utilizing historic abutments. Stone abutments, steel stringers, pressure-treated lumber decking and railings. ~8' wide, 70' long.

Happy Isles West Bridge.

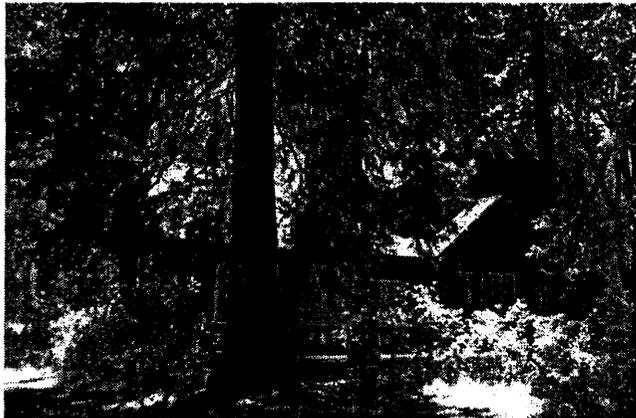
PART III: BUILDING AND STRUCTURE INVENTORY
Supplemental Information for Section 7Yosemite Village Resources
Buildings**YOSEMITE VILLAGE RESOURCES: Buildings****BUILDING NAME:** Superintendent's House**STRUCTURE #/ LCS****ID #:** VA00001 / 012023**MAP #:** Map B, B1**DESCRIPTION:** Built 1912. 2 story, frame with porches, bays & terraces on several sides which mask basic square shape. Horizontal lap siding on 1st floor, board & batten on 2nd. Gable roof with shed portions on porches & dormers. Exposed rafters at eaves. Stone chimney.

Superintendent's House, looking southwest

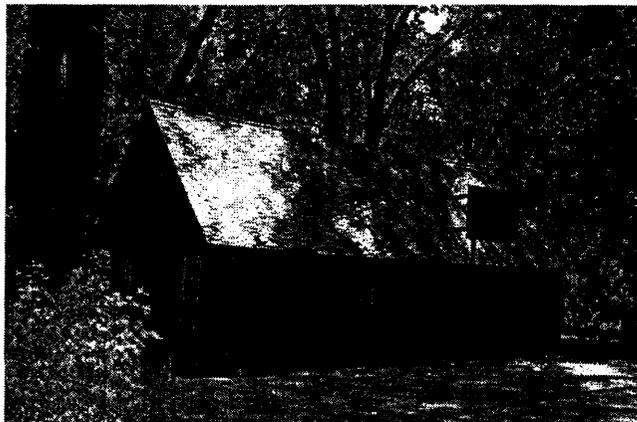
BUILDING NAME: Superintendent's Garage**STRUCTURE #/ LCS****ID #:** VA00300 / 055757**MAP #:** Map B, B2**DESCRIPTION:** Built 1929. 2-stall garage, wood frame covered with horizontal redwood drop siding. Enclosed portion for wood storage. Gable roof covered w/ wood shingles.

Superintendent's Garage, looking southwest.

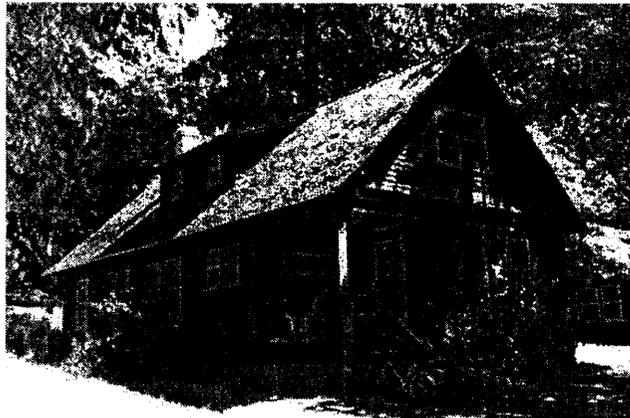
DESCRIPTION: Built in 1911. 1 story house, wood frame with wood shingled gable roofs and exterior brown-stained horizontal siding with coursed wood shakes at the gable ends. Brackets support front eaves. The interior has a finish of painted wood wainscot and above it an unusual board and batten wall and ceiling finish in living and dining room areas. Small front porch. Represents "Army Architecture." Moved in 1921 from old village to new village.

Yosemite Village Residence 2, looking northwest.

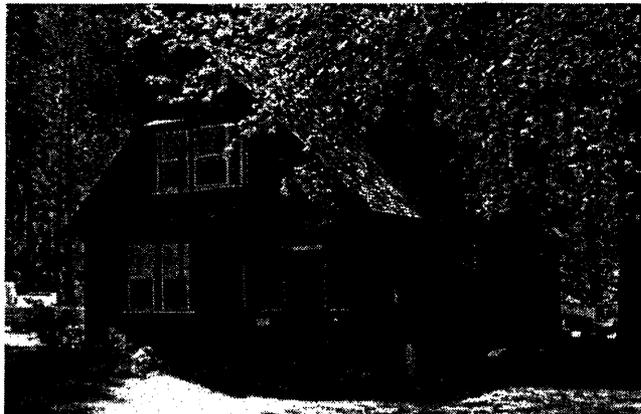
DESCRIPTION: Built 1911. Wood frame 1 story house with wood shingled gable roofs and exterior brown-stained horizontal siding with coursed wood shakes at the gable ends. The interior has a finish of painted wood wainscot and above it an unusual board and batten wall and ceiling finish in living and dining room areas. Represents "Army Architecture." Same design as building #5. Moved.

Yosemite Village Residence 4, looking southwest.

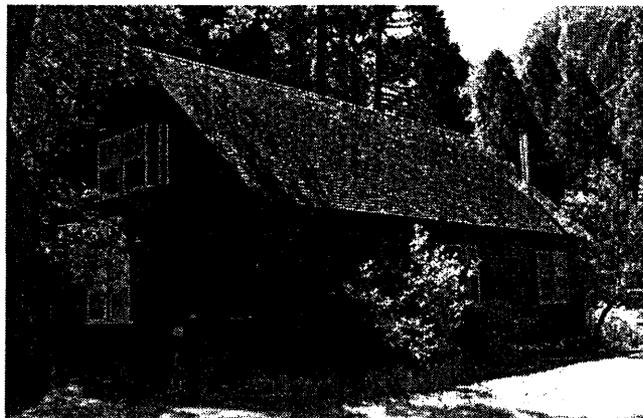
Yosemite Village Residence 5

DESCRIPTION: Built 1912. Wood frame 1 story, rectangular house with wood shingled gable roofs and exterior brown-stained horizontal siding with coursed wood shakes in some areas such as the gable ends. Dormer window added in 1947. Shallow bay window on 2nd floor, front. Small porch, front. The interior has a finish of painted wood wainscot and above it an unusual board and batten wall and ceiling finish in living and dining room areas. 1 over 1 double hung with wooden surrounds. Represents "Army Architecture." Same design as building #4. Moved.

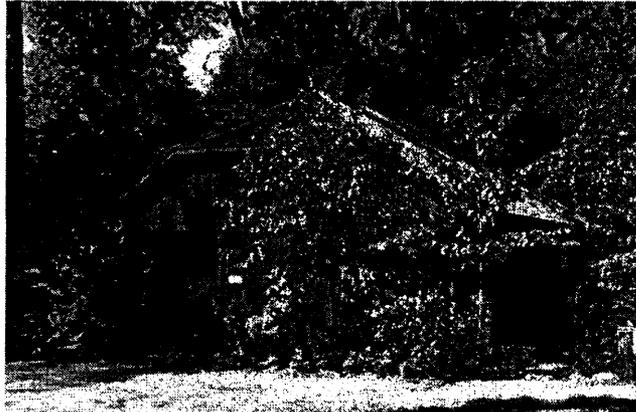
BUILDING NAME: Yosemite Village Residence 6
STRUCTURE #/ LCS
ID #: VA00006 / 012028
MAP #: Map B, B7
DESCRIPTION: Built 1920. 1 story. Lower portion is finished as wainscoting with shingles and topped with vertical board & batten to eaves. Windows are double hung 6 over 6. Porch in front corner. Jerkinhead roof is covered with shingles.

Yosemite Village Residence 6, looking west.

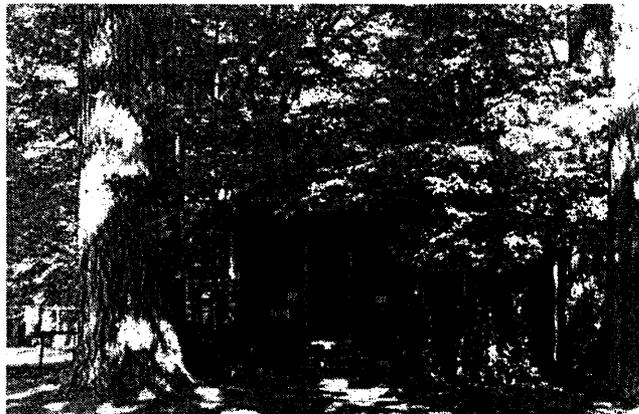
BUILDING NAME: Yosemite Village Residence 7
STRUCTURE #/ LCS
ID #: VA00007 / 012029
MAP #: Map B, B8
DESCRIPTION: 1920. 1 story, frame. Concrete foundation with stone veneer. Exterior is sided with coursed shake wainscot topped with board and batten finish above. Windows are 6 over 6 double hung, wood sash. Jerkinhead roof is wood shingled.

Yosemite Village Residence 7, looking west.

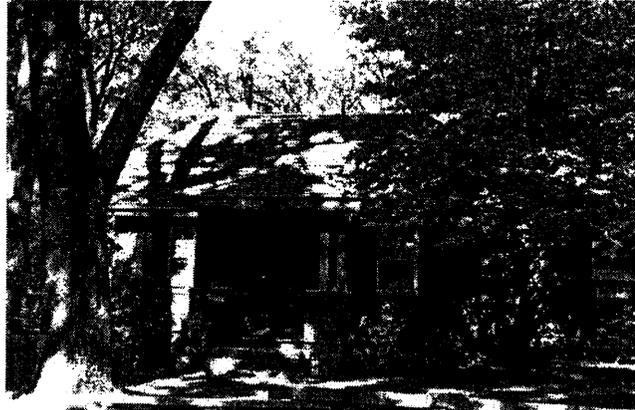
BUILDING NAME: Yosemite Village Residence 8
STRUCTURE #/ LCS
ID #: VA00008 / 012030
MAP #: Map B, B9
DESCRIPTION: Built 1920. 1 story, frame. Concrete foundation with stone veneer. Exterior is sided with coursed shake wainscot topped with board and batten finish to eaves. Wood shingled Jerkinhead roof. Front porch with solid balusters & hipped roof supported by vertical posts.

Yosemite Village Residence 8, looking west.

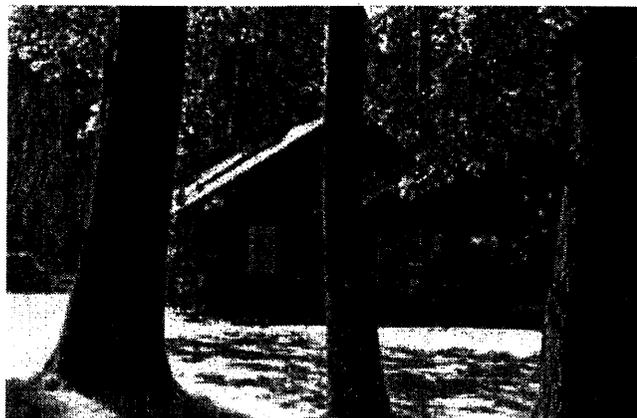
BUILDING NAME: Yosemite Village Residence 9
STRUCTURE #/ LCS
ID #: VA00009 / 012031
MAP #: Map B, B10
DESCRIPTION: Built 1922. 1 story, frame. Sided with horizontal wood lap. Gabled roof is shingled. Front has gable roof over open porch. Enclosed porch & storage room both covered with shed roof. Foundation covered with skirt board. Stone & concrete chimney added later

Yosemite Village Residence 9, looking east.

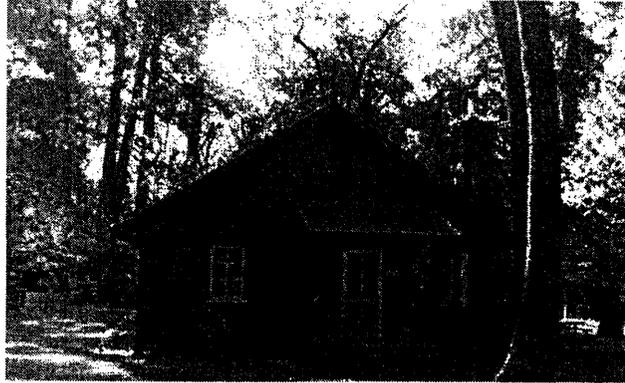
PART III: BUILDING AND STRUCTURE INVENTORY
Supplemental Information for Section 7Yosemite Village Resources
Buildings**BUILDING NAME:** Yosemite Village Residence 10**STRUCTURE # / LCS****ID #:** VA00010 / 012032**MAP #:** Map B, B11**DESCRIPTION:** Built 1922. 1 story, frame. Sided with horizontal wood lap. Gabled roof is shingled. Front has gable roof over open porch. Enclosed porch & storage room both covered with shed roof. Foundation covered with skirt board. Stone & concrete chimney added later. Enclosed porch & storage with shed roof at rear.

Yosemite Village Residence 10, looking east.

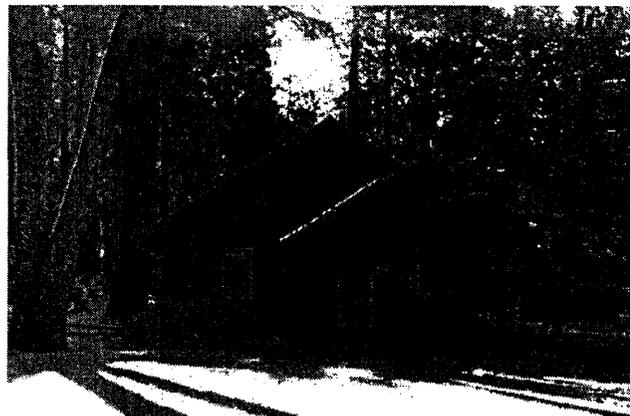
BUILDING NAME: Yosemite Village Residence 11**STRUCTURE # / LCS****ID #:** VA00011 / 012033**MAP #:** Map B, B12**DESCRIPTION:** Built 1924. 1 story, frame. Sided with horizontal wood lap. Gabled roof is shingled. Front has gable roof over open porch. Enclosed porch & storage room both covered with shed roof. Foundation covered with skirt board. Stone & concrete chimney added later. Glass enclosed porch at rear.

Yosemite Village Residence 11, looking east.

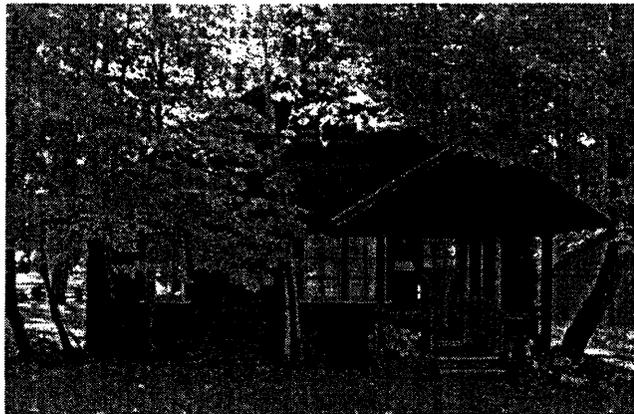
Yosemite Village Residence 12, looking east.

BUILDING NAME: Yosemite Village Residence 12
STRUCTURE #/ LCS
ID #: VA00012 / 012034
MAP #: Map B, B13
DESCRIPTION: Built 1922. 1 story, frame. Sided with horizontal wood lap. Gabled roof is shingled. Front has gable roof over open porch. Enclosed porch & storage room both covered with shed roof. Foundation covered with skirt board. Stone & concrete chimney added later.

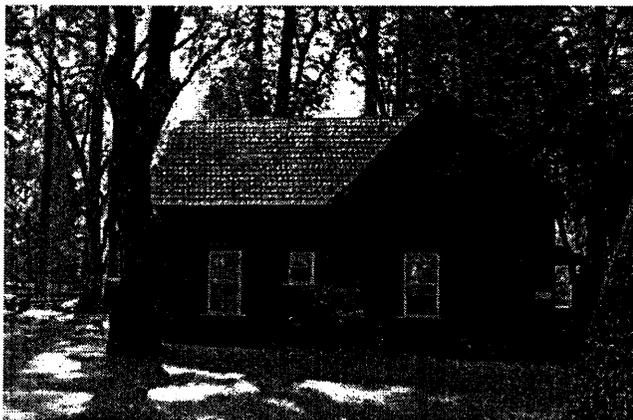
BUILDING NAME: Yosemite Village Residence 13
STRUCTURE #/ LCS
ID #: VA00013 / 012035
MAP #: Map B, B14
DESCRIPTION: Built 1914. Shake finished exterior. Shingle finished gable roof, and interior surfaces of painted wood, vertical paneling of railroad car siding. Some partitions are a single board thick with exposed framing on one side. Foundation is rock. Glass enclosed porch at rear. Represents "Army Architecture." Moved.

Yosemite Village Residence 13, looking east.

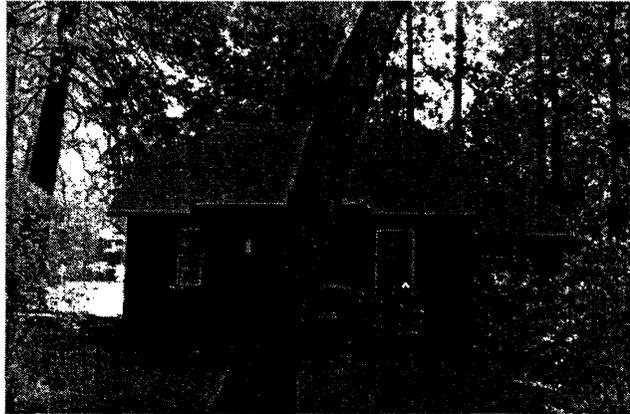
Yosemite Village Residence 14, looking east.

BUILDING NAME: Yosemite Village Residence 14
STRUCTURE #/ LCS
ID #: VA00014 / 012036
MAP #: Map B, B15
DESCRIPTION: Built 1924. 1 story nearly square frame house. Sided with wainscot of horizontal coursed wood shakes which is topped with vertical board and batten. Jerkinhead roof is shingled. Small front porch with hipped roof, supported by corner posts.

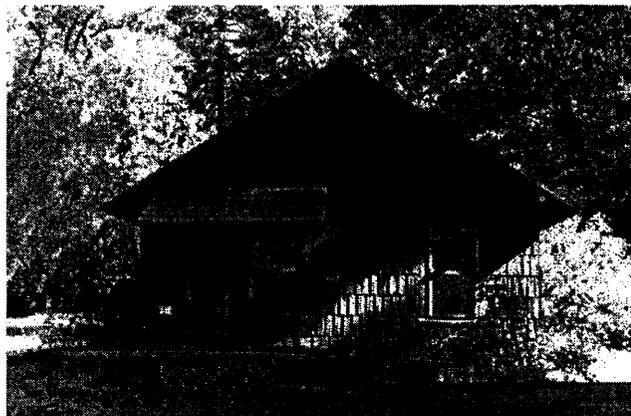
Yosemite Village Residence 16, looking north.

BUILDING NAME: Yosemite Village Residence 16
STRUCTURE #/ LCS
ID #: VA00016 / 012037
MAP #: Map B, B16
DESCRIPTION: Built 1923. 1 story frame. 20' x 22'. Exterior walls and gable roof are covered with wooden shingles. Small porch with shed roof at front entrance. Windows are 6 over 6. Foundation and crawl space are obscured by skirt board.

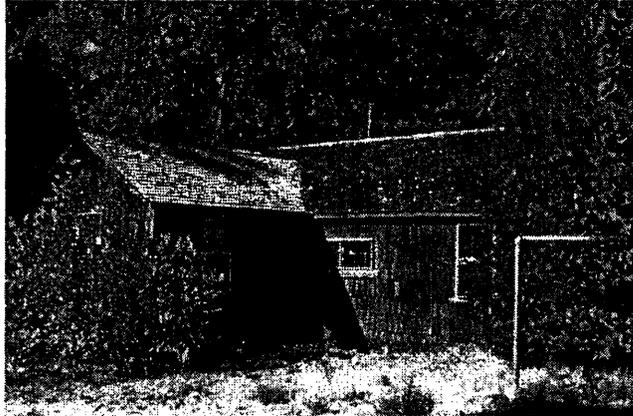
Yosemite Village Residence 17, looking southwest.

DESCRIPTION: Built 1926. 1 story, wood frame, + shaped. Sided with coursed wood shakes. Gabled roof is covered with wood shingles. Small front porch is sided & covered with shed roof, supported by corner posts. Known locally as "the airplane." Interior walls and ceilings are full height wood paneling of railroad car-siding.

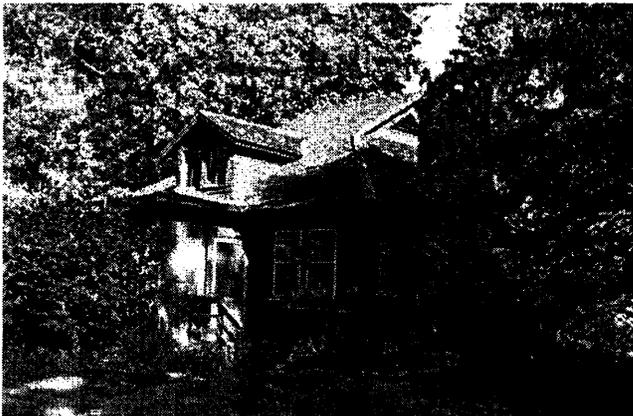
Yosemite Village Residence 18, looking northwest.

DESCRIPTION: Built 1919. 1 story, wood frame. Sided with high band of wainscot of coursed wood shingles, topped with a banding of board & batten siding from mid-window height to under the eaves. Hipped gable roof is covered with wood shingles. Rock and concrete chimney on side.

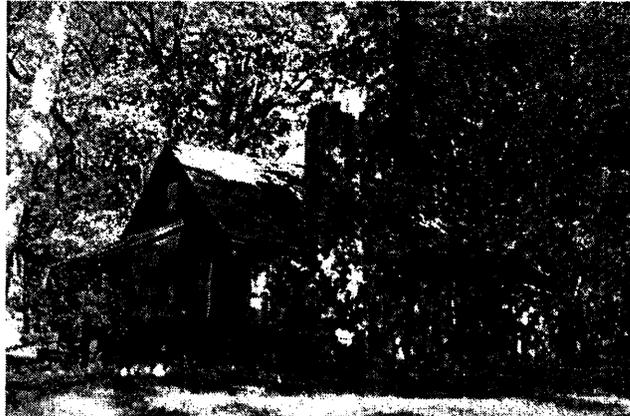
Yosemite Village Residence 19, looking west.

BUILDING NAME: Yosemite Village Residence 19
STRUCTURE #/ LCS
ID #: VA00019 / 012040
MAP #: Map B, B19
DESCRIPTION: Built 1919. 1 story, wood frame. Gabled roof covered with wood shingles. Open front porch is covered with shed roof, also shingled. Glass enclosed porch at rear. Foundation covered by skirt boards. Rock and concrete chimney on side.

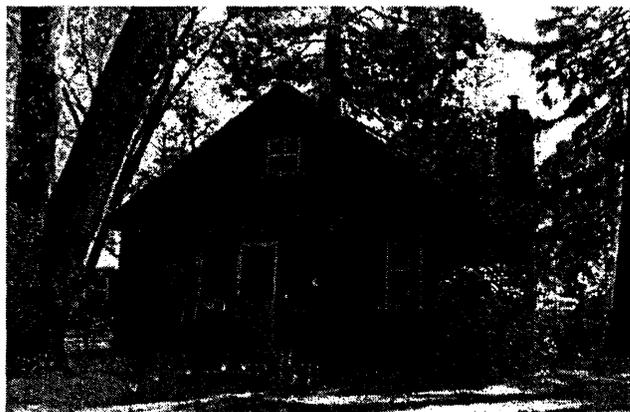
Yosemite Village Residence 20, looking east.

BUILDING NAME: Yosemite Village Residence 20
STRUCTURE #/ LCS
ID #: VA00020 / 012041
MAP #: Map B, B20
DESCRIPTION: Built 1918. 1 story, wood frame. Sided with coursed wood shakes. Gabled roof is covered with wood shingles. Fixed window in gable end. Front porch is screened, with a shed roof. Glass enclosed porch at rear. Rock and concrete chimney on side.

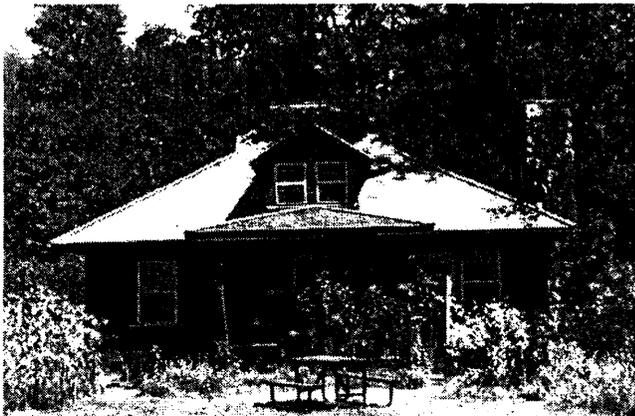
Yosemite Village Residence 21, looking east.

DESCRIPTION: Built 1919. 1 story, wood frame. Lower $\frac{3}{4}$ of walls covered with wainscot of coursed wood shakes, upper quarter to eaves board & batten. Hipped, gable roof is covered with wood shingles. Rock & concrete chimney on side, added later. Dormer on front.

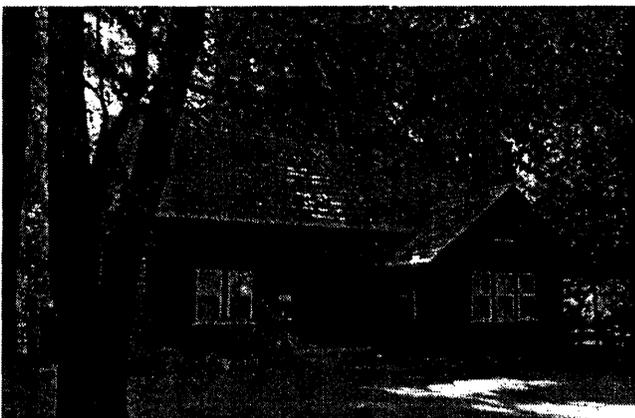
Yosemite Village Residence 34, looking east.

DESCRIPTION: Built 1930. 2 story, wood frame. Horizontal drop siding at ground floor with broad and narrow coursed wood shakes on the second level & at gable ends. Stone & concrete terrace and chimney on side. Gabled roof is wood shingled. Varied roof heights.

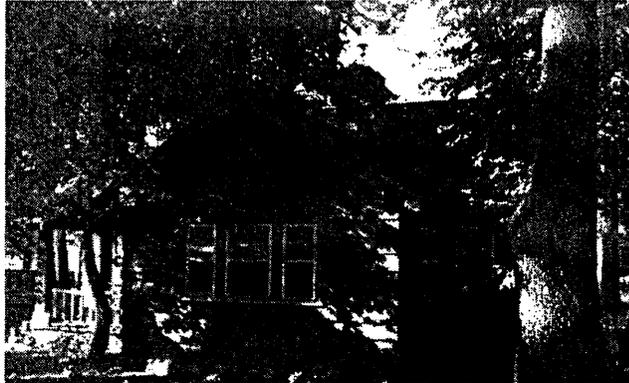
Yosemite Village Residence 35, looking south.

Built 1938. 1 story wood frame house. Horizontal drop siding. Foundation is stone and concrete. Gabled roof with wood shingles. Stone chimney. Shed roof over front porch. Glass enclosed porch in rear.

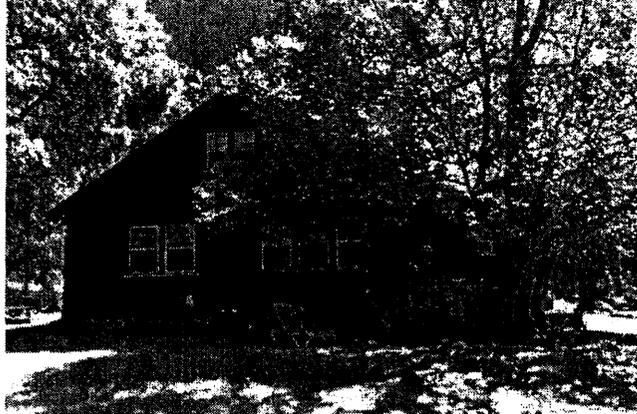
Yosemite Village Residence 37, looking east.

Built 1938. 1 story wood frame house. Horizontal wood siding. Foundation is stone and concrete. Gabled roof with wood shingles. Central stone chimney. Stone steps to porch.

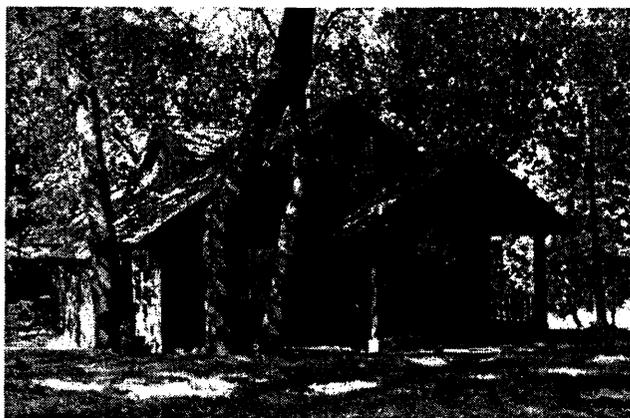
Yosemite Village Residence 40.

BUILDING NAME: Yosemite Village Residence 40
STRUCTURE #/ LCS
ID #: VA00040 / 100244
MAP #: Map B, B27
DESCRIPTION: Built 1927. 1 story wood frame house. Horizontal wood siding. Gabled roof with wood shingles. Open front porch with gabled roof supported by posts. Dormer on SE side. Central stone chimney. Interior is wainscot car-siding, walls and ceilings of beaver-board type panels finished with wood battens.

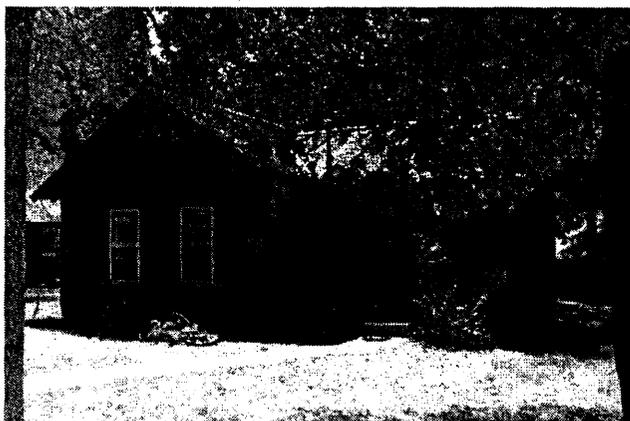
BUILDING NAME: Yosemite Village Residence 41
STRUCTURE #/ LCS
ID #: VA00041 / 005742
MAP #: Map B, B28
DESCRIPTION: Built 1937. 1 story wood frame house. Sided in coursed wood shakes. Gabled roof with wood shingles. Open porch. Foundation covered by skirt board. Interior is wainscot car-siding, walls and ceilings of beaver-board type panels finished with wood battens.

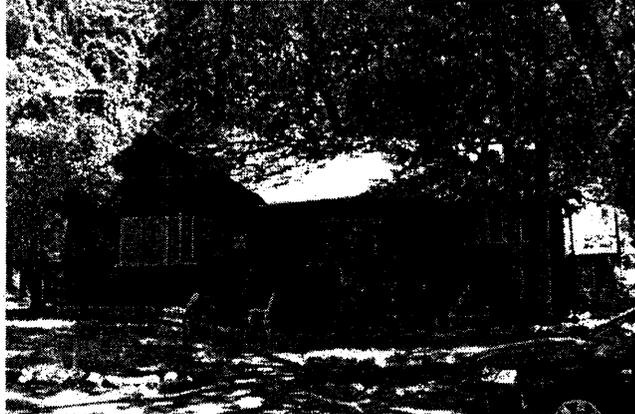
BUILDING NAME: Yosemite Village Residence 42
STRUCTURE #/ LCS
ID #: VA00042 / 005743
MAP #: Map B, B29
DESCRIPTION: Built 1928. 2 story wood frame house. Horizontal wood siding. Irregular plan, entrance through open, front-porch with shield roof. Gabled roof with wood shingles. Windows are 6-lite casement. Stone fireplace.

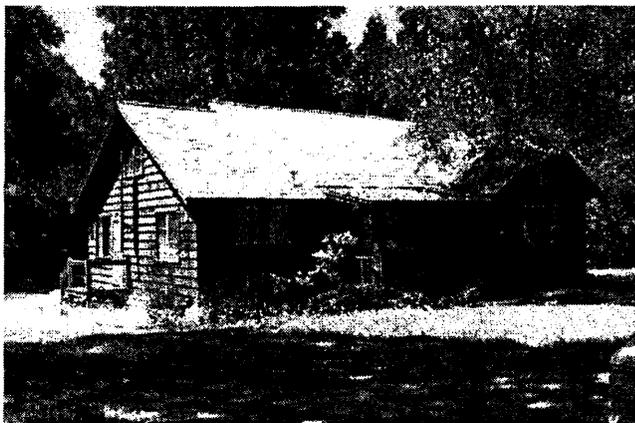
Yosemite Village Residence 43.

BUILDING NAME: Yosemite Village Residence 43
STRUCTURE #/ LCS
ID #: VA00043 / 05744
MAP #: Map B, B30
DESCRIPTION: Built 1928. 1 story wood frame house. Horizontal drop siding. Gabled roof with wood shingles. Large dormer facing rear. Stone chimney. Front porch with shed roof.

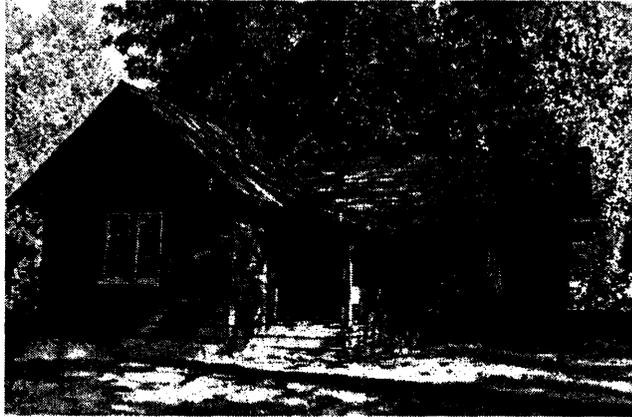
Yosemite Village Residence 44, facing west.

PART III: BUILDING AND STRUCTURE INVENTORY
Supplemental Information for Section 7Yosemite Village Resources
Buildings**BUILDING NAME:** Yosemite Village Residence 44**STRUCTURE #/ LCS****ID #:** VA00044 / 005745**MAP #:** Map B, B31**DESCRIPTION:** Built 1929. 1 story, L - shaped, wood frame. Horizontal wood siding. Gabled roof with wood shingles. Windows are 6-lite casement, arranged in pairs, some with shutters. Front porch with shed roof.

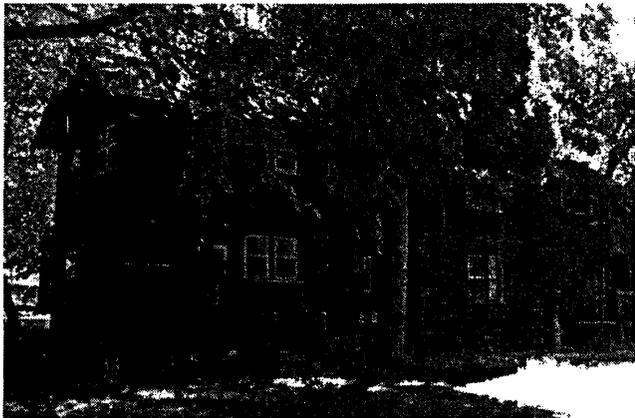
Yosemite Village Apartment 46, looking east.

Built 1930. 2 story, wood frame. Horizontal wood siding on ground floor, 2nd is vertical board and batten. Gable ends are broad & narrow banded wood shakes. Gabled roof with wood shingles. Open gallery porch at entry on each floor.

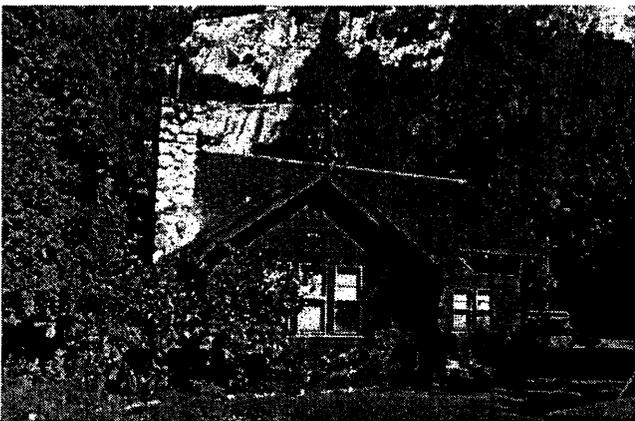
Built 1931. 2 story, wood frame. Horizontal wood siding on ground floor, 2nd is broad and narrow bands of wood shakes. Gabled roof with fish scale pattern wood shakes. Stone and concrete terrace and chimney.

Yosemite Village Residence 47, facing east.

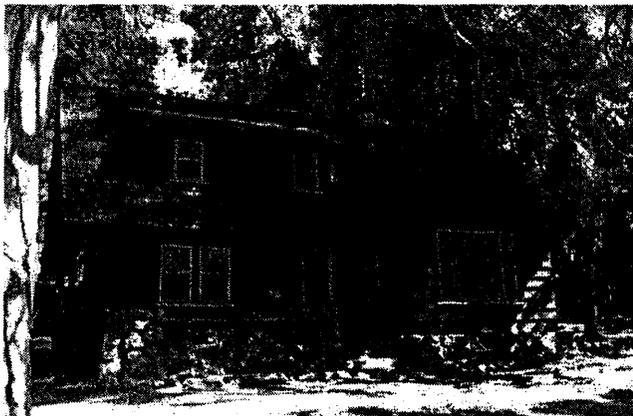
Yosemite Village Residence 48.

PART III: BUILDING AND STRUCTURE INVENTORY
Supplemental Information for Section 7Yosemite Village Resources
Buildings**BUILDING NAME:** Yosemite Village Residence 48**STRUCTURE #/ LCS****ID #:** VA00048 / 005749**MAP #:** Map B, B35**DESCRIPTION:** Built 1931. 1 story, wood frame. Horizontal wood siding. Gable ends have broad and narrow bands of wood shakes. Gabled roof with wood shingles. Long dormer facing front. Stone and concrete foundation, terrace and chimney.

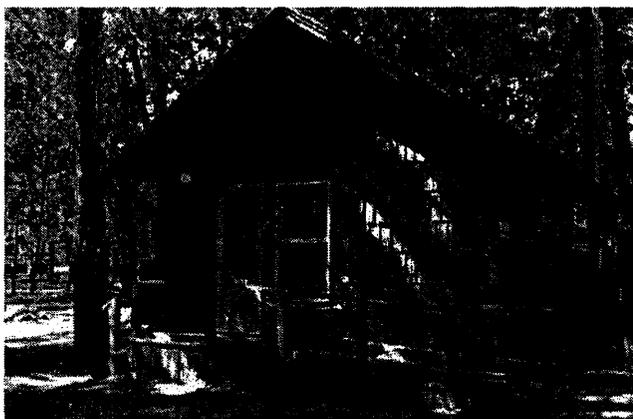
BUILDING NAME: Yosemite Village Girls' Dormitory 54**STRUCTURE #/ LCS****ID #:** VA00054 / 005750**MAP #:** Map B, B36**DESCRIPTION:** Built 1923. 1 story, wood frame, 16' x 32'. Shake siding. Gable roof with wood shingles. Skirt board covers foundation. Originally constructed as two bedroom and one bath girl's dormitory.

Yosemite Village Girls' Dormitory 54, looking south.

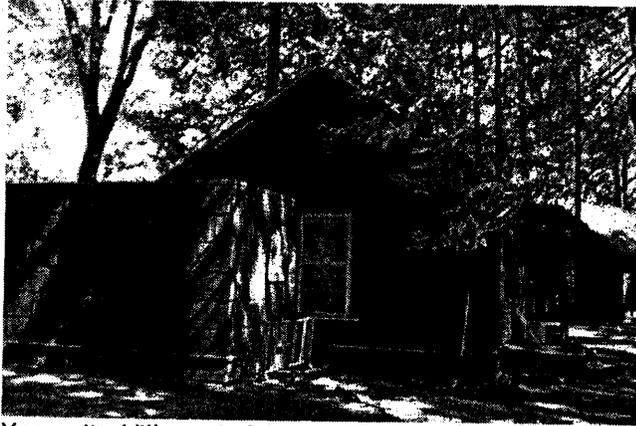
BUILDING NAME: Yosemite Village Girls' Dormitory 55
STRUCTURE #/ LCS
ID #: VA00055 / 005751
MAP #: Map B, B37
DESCRIPTION: Built 1923. 1 story, wood frame, 16' x 32'. Shake siding. Gable roof with wood shingles. Skirt board covers foundation. Originally constructed as two bedroom and one bath girl's dormitory. Altered by addition of new door and porch.

Yosemite Village Girls' Dormitory 55, facing north.
